Lockheed F-104

Airworthiness Certification

AIR-230 Airworthiness Certification Branch
Federal Aviation Administration
Washington, D.C.
January 21, 2013

Introduction – F-104 Airworthiness Certification

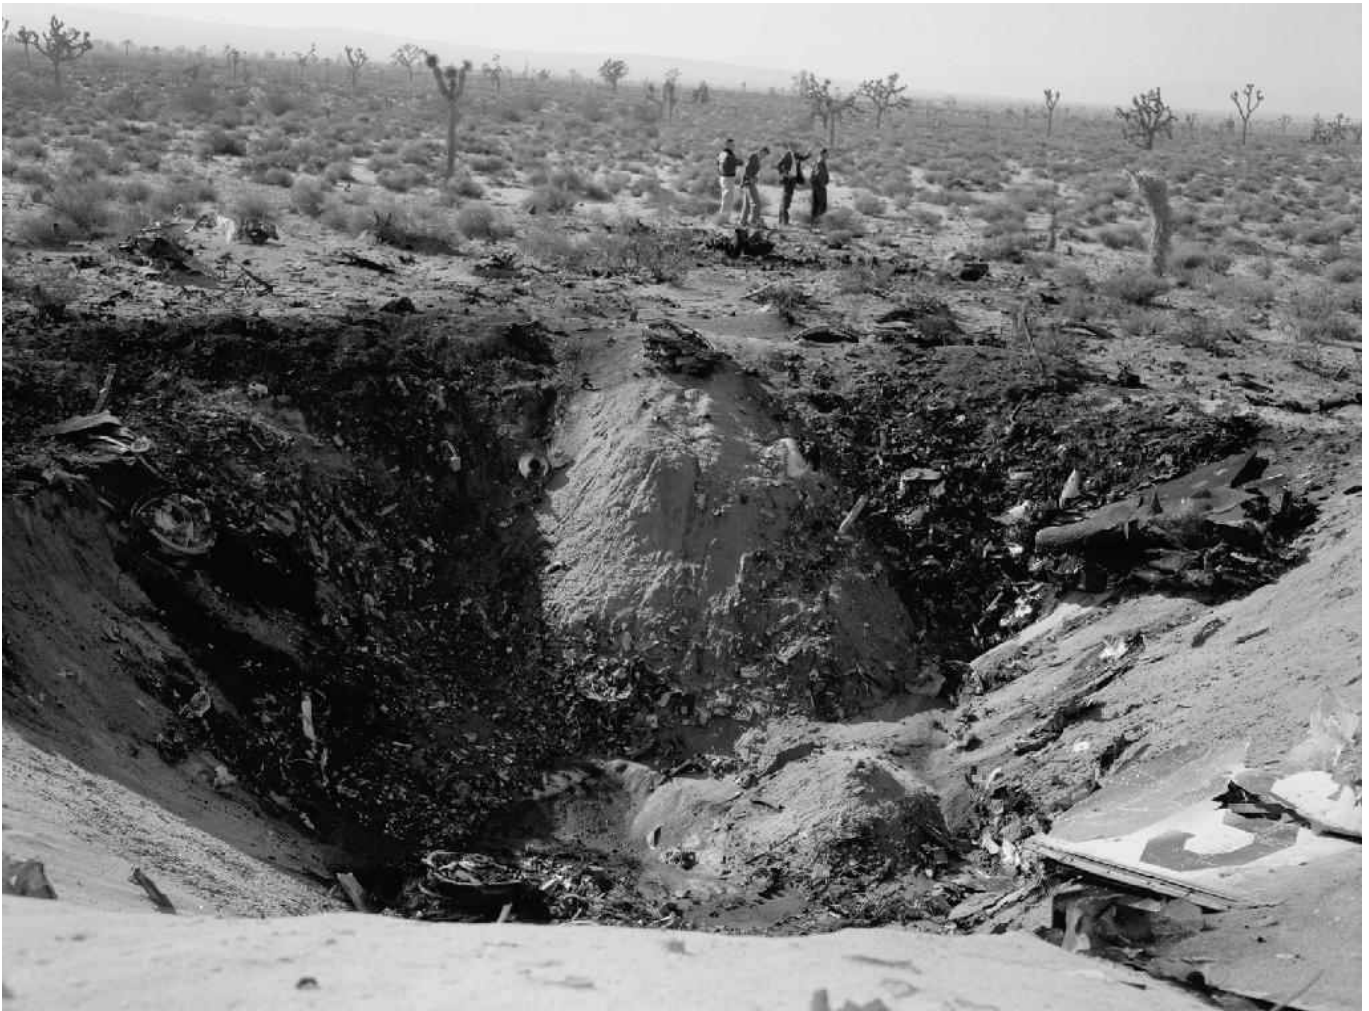
Investigators pore over the site of the nose-first, high-impact JF-104A crash that left this large crater in the desert near Edwards Air Force Base in December 1962. NASA test pilot Milton O. Thompson ejected from this aircraft on Dec. 20, 1962, after an asymmetrical flap condition made the jet uncontrollable. Source: NASA. Below, a view of the crash of a Luftwaffe F-104G. It crashed on May 17, 1966 at RAF Gutersloh after an emergency landing with open nozzle. It landed with a tail wind, and failed to engage the barrier. The landing gear was ripped, the pilot was injured, and it was struck off charge on June 15, 1966. Source: <http://www.916-starfighter.de>.

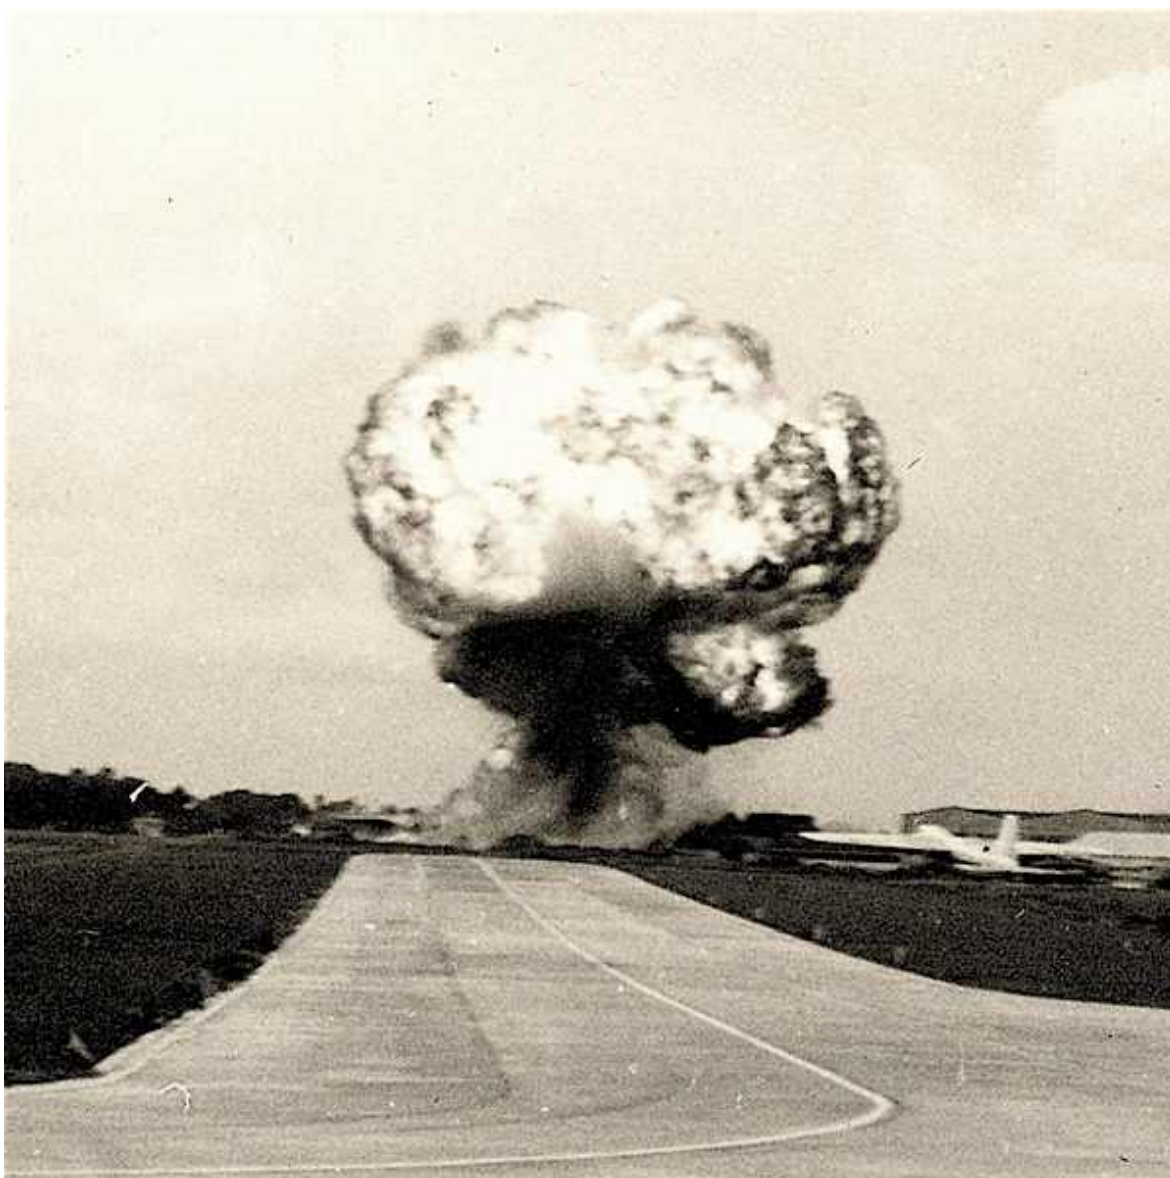
August 18, 1964. A Belgian Air Force F-104 crashes during a low level demonstration. The aircraft crashed onto a hangar. The pilot was killed, Kapt.vl. Pierre Tonet, while several aircraft were destroyed in the hangar. This accident was a clear indication of the F-104's flight characteristics, which cannot be under estimated. Source: <http://aviation-safety.net/wikibase/wiki.php?id=47170>.

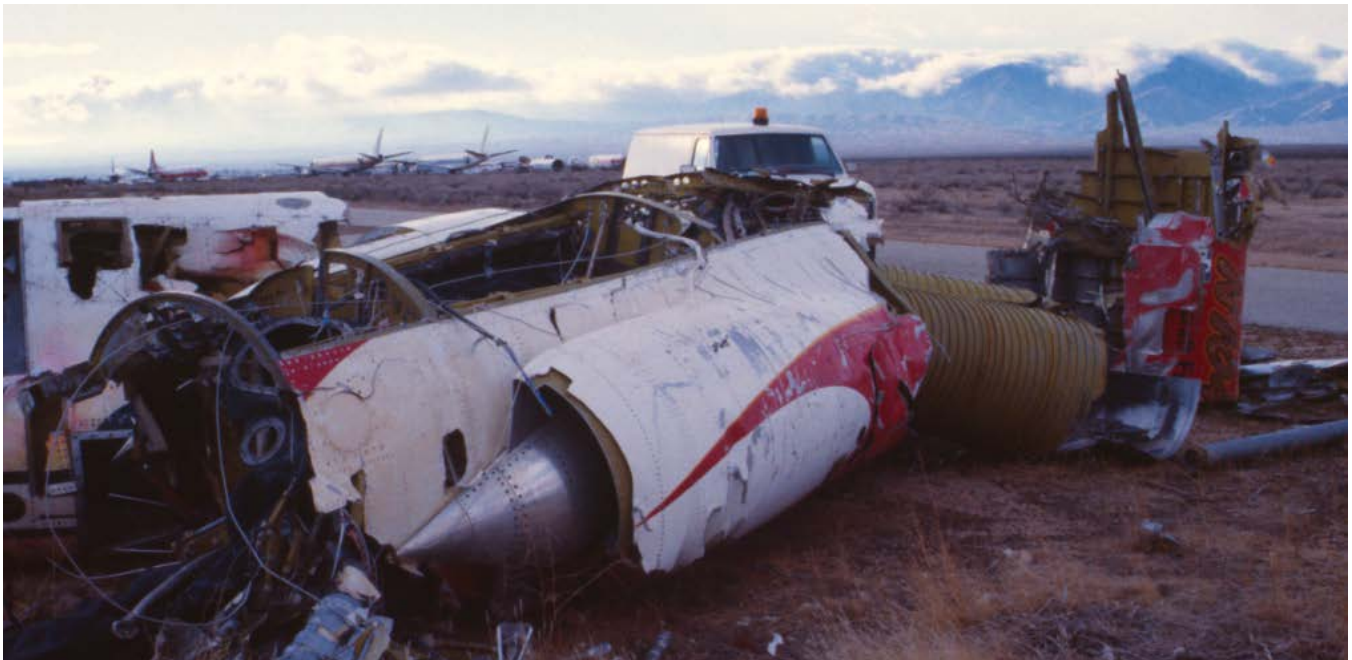
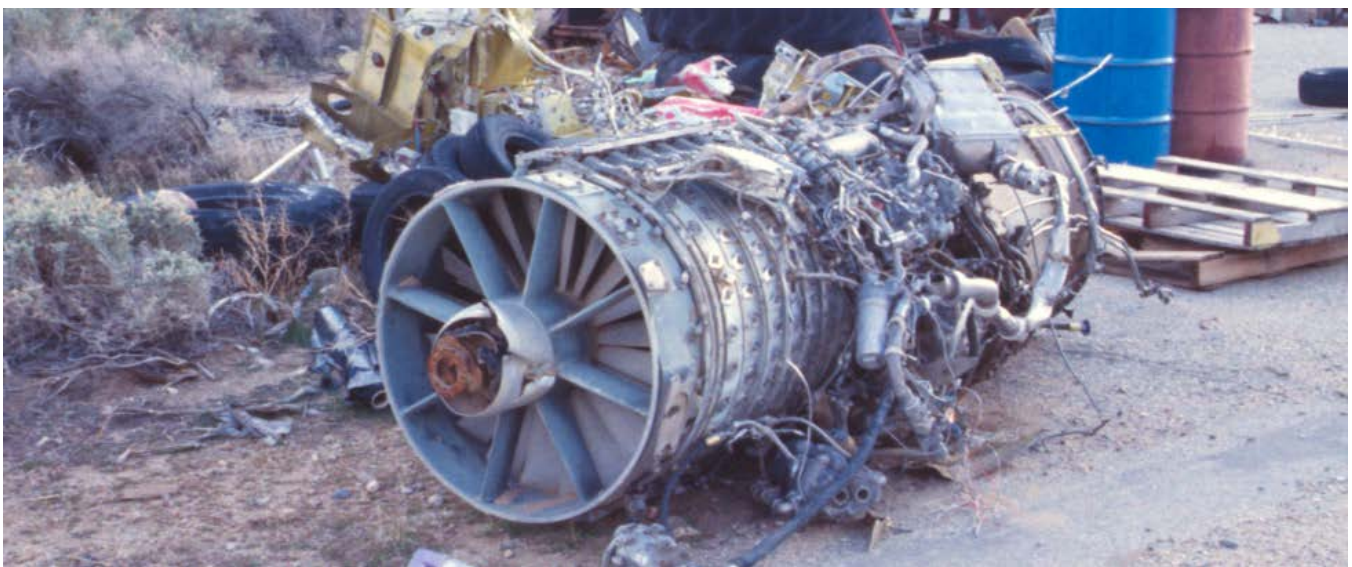
The remains of N104RB, the "Red Baron" F-104 after the 1977 accident. Source David Lednicer. Copyright © 2013.

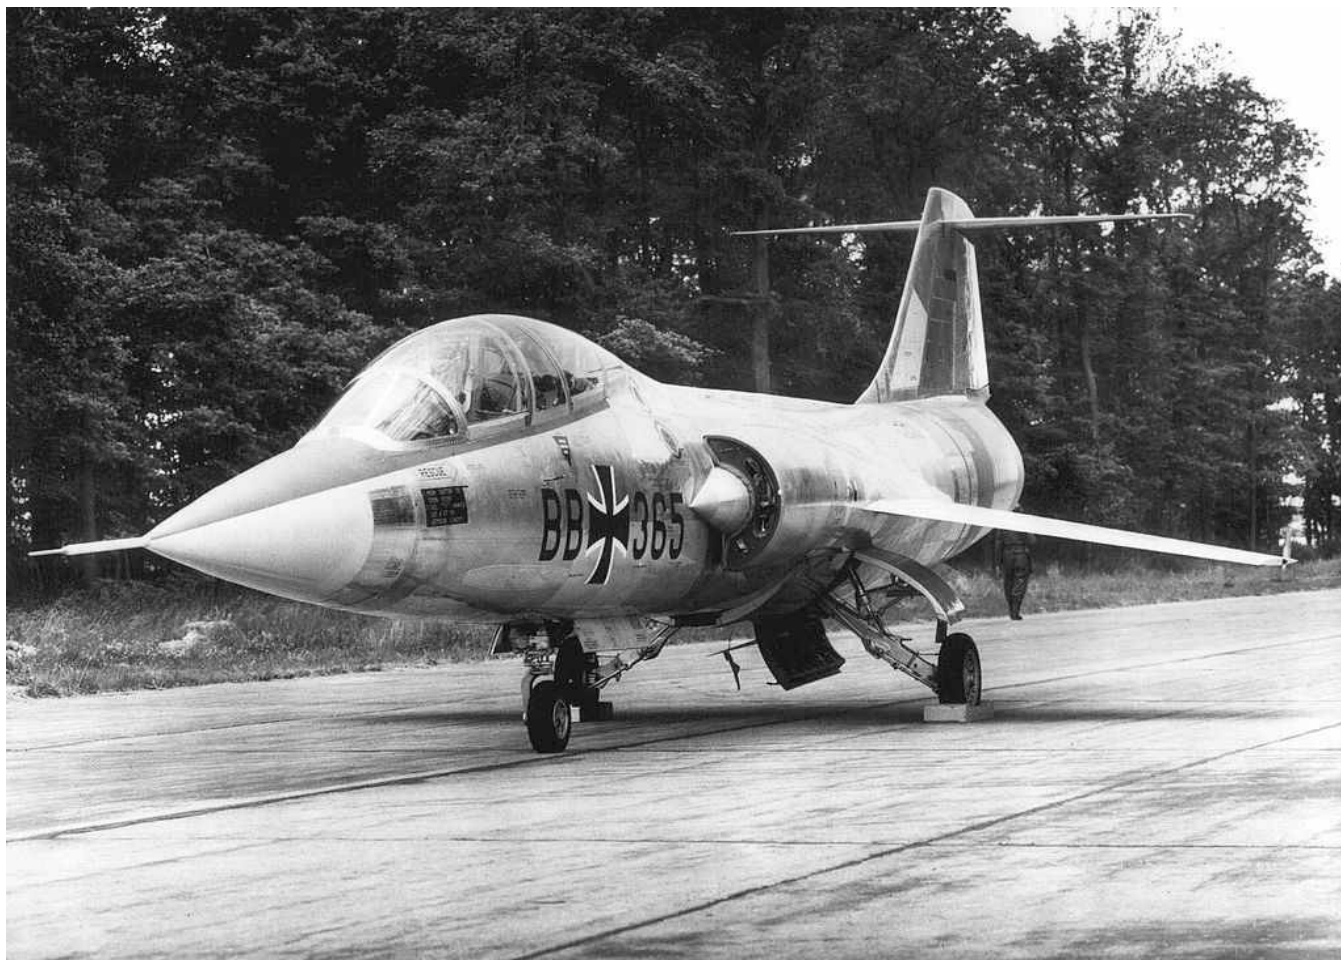
A West German Luftwaffe Lockheed F-104F Starfighter aircraft (serial BB+365), in 1960. This aircraft was lost on 19 June 1962 near Knapsack, Nordrhein-Westfalen (Germany), when four planes crashed into the ground after disorientation of the leader. All pilots, three Germans and one American, were killed. Source: U.S. Army.

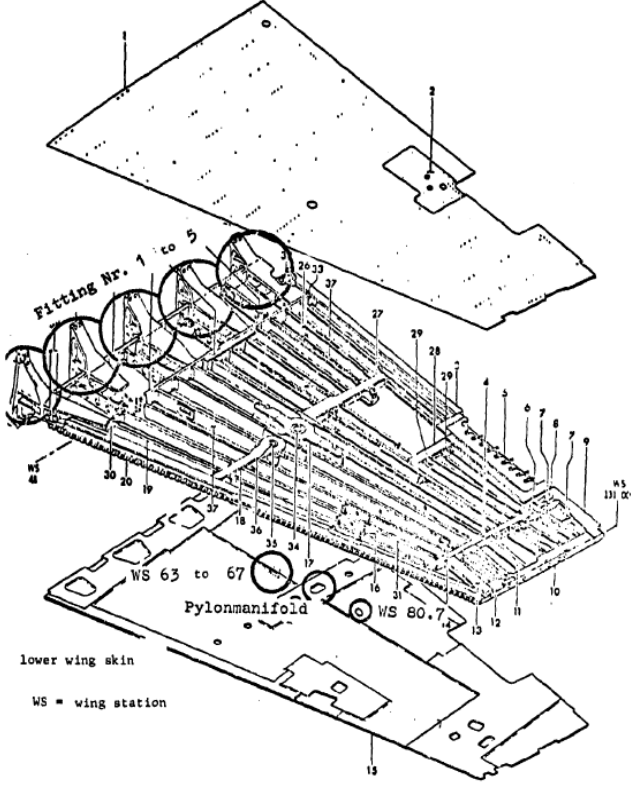
Issue #	Issue(s)	Recommended Review, Action(s), and Coordination with Applicant	Notes, Action(s) Taken, and Disposition
149.	Wing Structural Issues	<p>Verify the AIP incorporates the latest guidance (likely Italian Air Force data from 2006) on the correct inspection and maintenance, including replacement (life limit) of the wing and related structures (especially the spars and wing attach point) per the applicable USAF/NATO requirements (Technical or Engineering Orders) including those addressing changes, fixes and other operational issues. In German Air Force service, the problem of structural failure of the wings emerged. Original fatigue calculations had not taken into account the high number of G-force loading cycles the German F-104 fleet was experiencing, and many airframes were returned for depot maintenance where their wings were replaced, while other aircraft were simply retired. Note: On F-104 G models, the fuselage, wing, and empennage were strengthened to enable the aircraft to carry an increased offensive weapons load and to handle the stresses of low-altitude combat missions flown at high speeds. A total of 36 new forgings were needed to reinforce the fuselage mainframes, wing fittings and beams, fuselage longerons, joints, and tail frames, empennage beams and ribs, plus some fuselage skins. Some reinforcement was made to the trailing-edge flap fittings to allow partial deflections of up to 15 degrees during combat maneuvers, allowing reductions of up to 33 percent in turning radius at altitudes of 5,000 feet. Note: The choice of the straight wing posed severe structural challenges in the F-104. To achieve acceptable supersonic performance, the wing had to be extremely thin (tapering from 4.2 inches deep at the fuselage to 1.96 inches at the tip), with very sharp leading and trailing edges (the leading edge had a nose radius of only 0.016 inches, or 0.041 cm). But the wing also has to be extremely rigid to avoid aileron-induced deflection and consequent control reversal. Lockheed's solution was to use a spar and transverse core machined from a single aluminum slab covered with single-piece, relatively thick (tapering from one-half inch to one quarter inch) upper and lower aluminum skins. The skin was shaped in a compression die, which produced both a very level wing surface and precisely formed rivet holes, which together permitted the extraordinarily smooth surface necessary for efficient supersonic flight. See <i>F-104 Fatigue Testing</i> below.</p>

Issue #	Issue(s)	Recommended Review, Action(s), and Coordination with Applicant	Notes, Action(s) Taken, and Disposition
150.	F-104 Fatigue Testing	Recommend that the AIP incorporate the relevant findings contained in TOTAL AIRFRAME FATIGUE TEST F 104 G - FINAL REPORT, Foreign Technology Division Wright-Patterson Air Force Base, Ohio, 20 March 1975. This report contains the most important information and "data on the experimental configuration, experimental sequence, and the results of the F-104G total airframe fatigue experiment. Details include all the damage information which occurred on the structure during the experiments. This report can be used as a means of orientation for the information contained in the partial reports because of the cross references in the text and the tables-This final report also contains an evaluation of the most important results (damage) and contains recommendations for their elimination, as well as modifications already made."

151.	Lower Wing Skins	Verify the AIP incorporates the latest guidance concerning the inspection (for damage) in the lower skin of the wing assembly in the region of the aileron servo (this has been documented in fatigue testing) and which led to the loss of aircraft.
